The Role of Site Conditions on the Structural Damage in the City of Valdivia during the 22 May 1960 M_w 9.5 Megathrust Chile Earthquake

César Pastén^{*1}, Felipe Campos², Felipe Ochoa-Cornejo¹, Sergio Ruiz³, Galo Valdebenito⁴, David Alvarado⁴, Felipe Leyton⁵, and Ricardo Moffat⁶

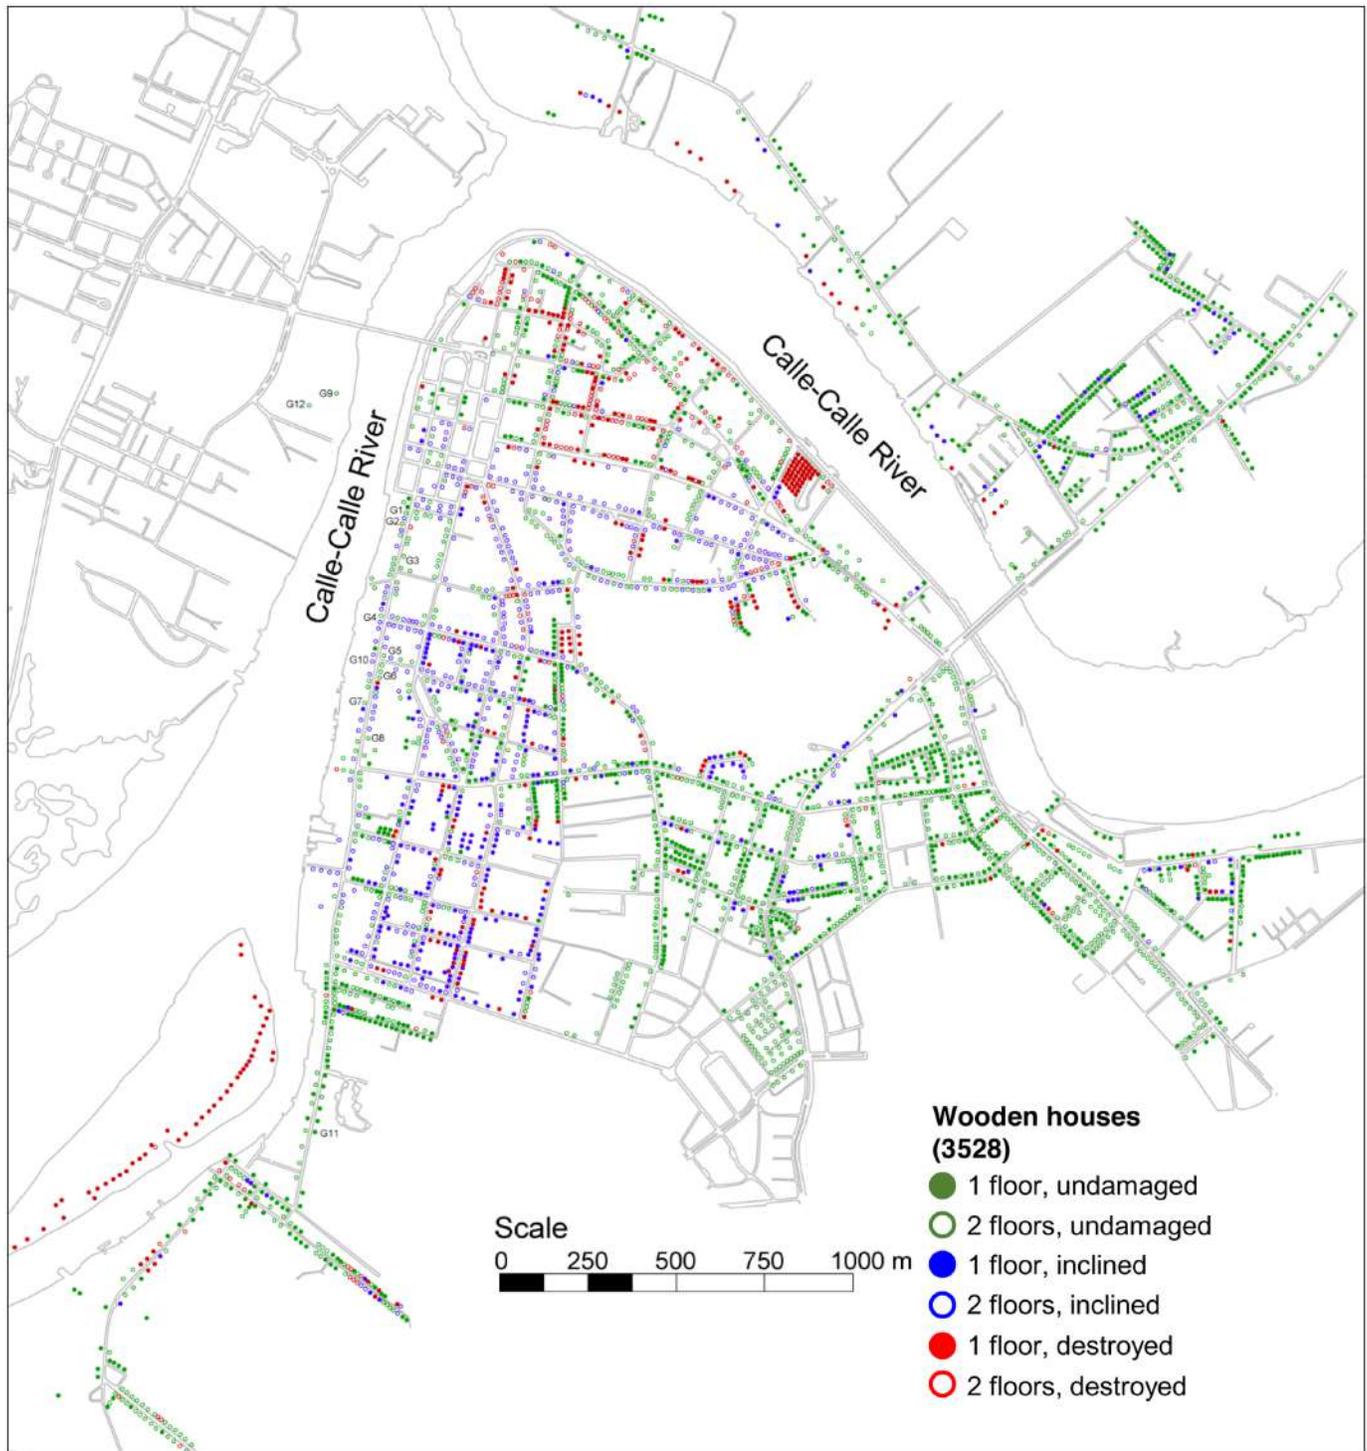
Figure 5. Wooden houses undamaged, inclined, and damaged during the 22 May 1960 Chile earthquake (data from Weischet, 1963; Barozzi and Lemke, 1966; Lástrico, 1967). The location of the 12 undamaged German-style wooden houses are indicated as G1–G12. The color version of this figure is available only in the electronic edition.

Figures 5 and 6 show the distribution of wooden and masonry houses in the city, respectively. Each figure indicates houses of one story and two stories that were undamaged,

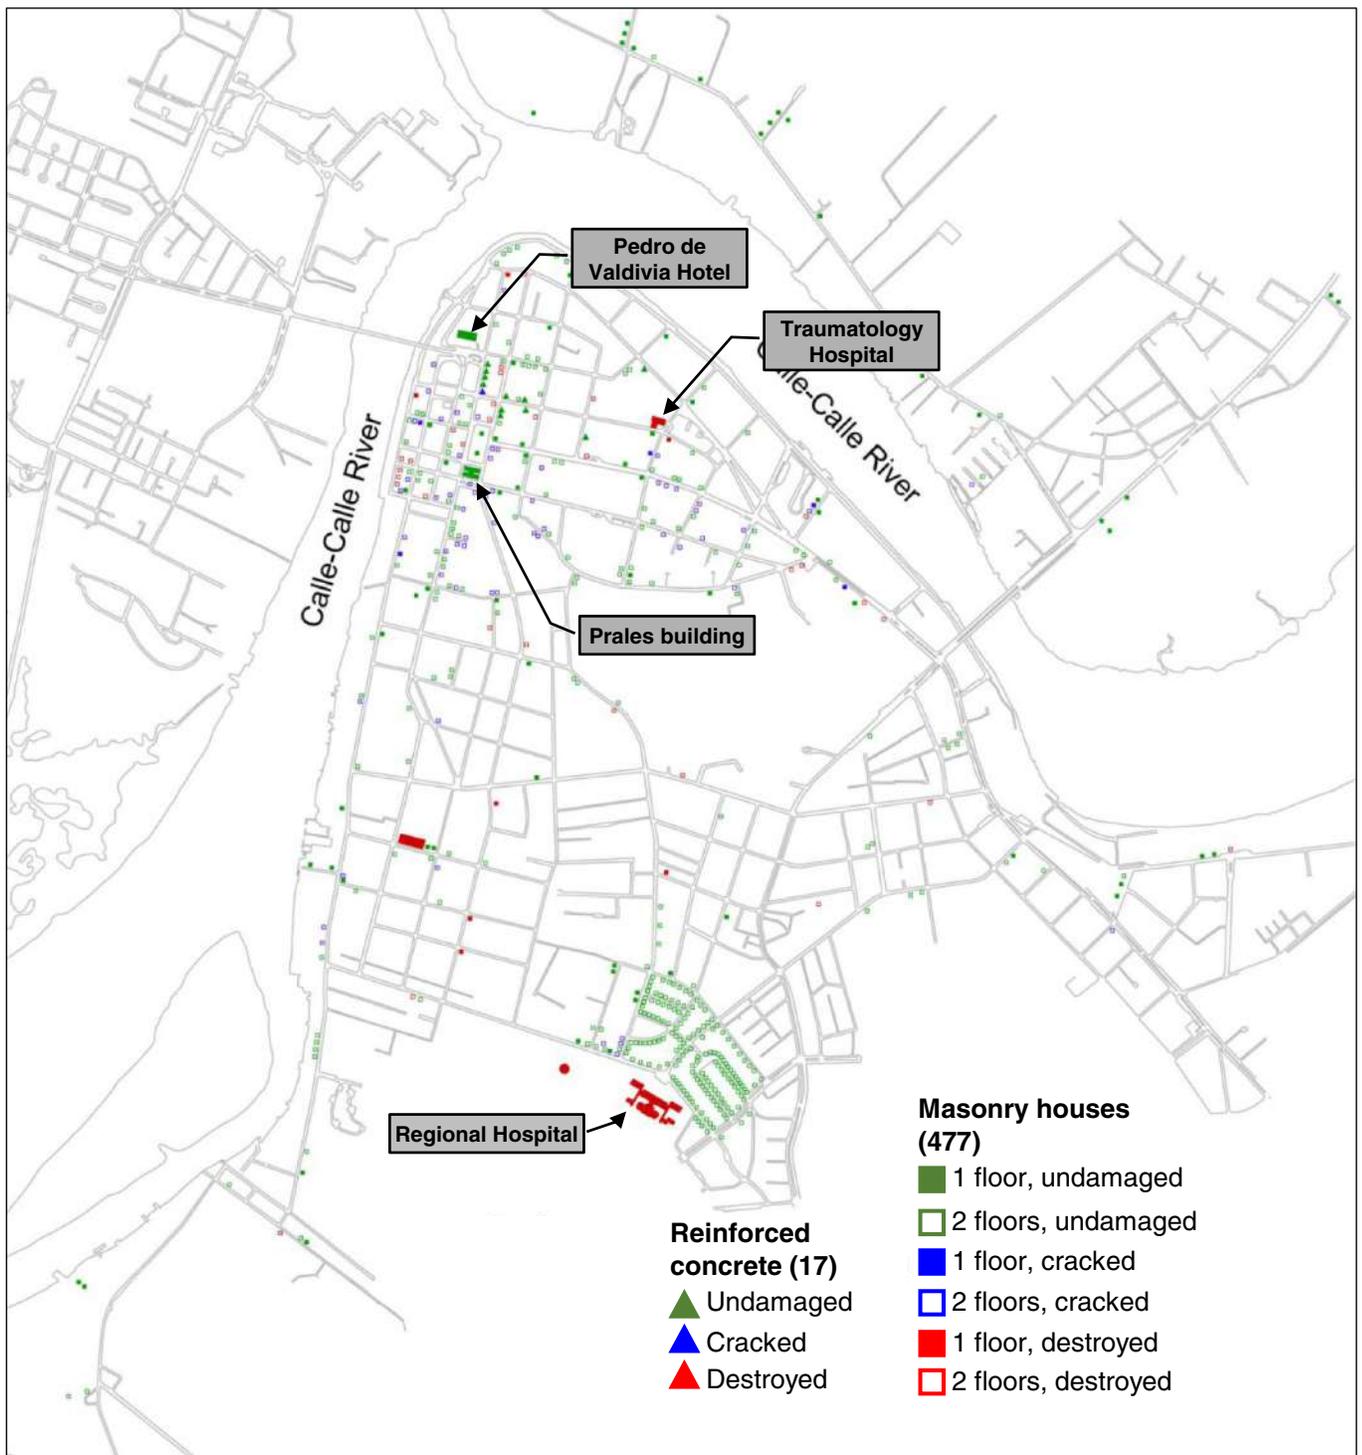
Figure 6. Masonry houses and reinforced-concrete structures undamaged, cracked, and damaged during the 22 May 1960 Chile earthquake (data from Weischet, 1963; Barozzi and Lemke, 1966; Lástrico, 1967). The color version of this figure is available only in the electronic edition.

inclined, cracked, and destroyed. Figure 6 also shows the reinforced-concrete buildings in the city. This study considers 4022 structures, from which 65% were undamaged, 21% resulted inclined or cracked, and 14% were destroyed.

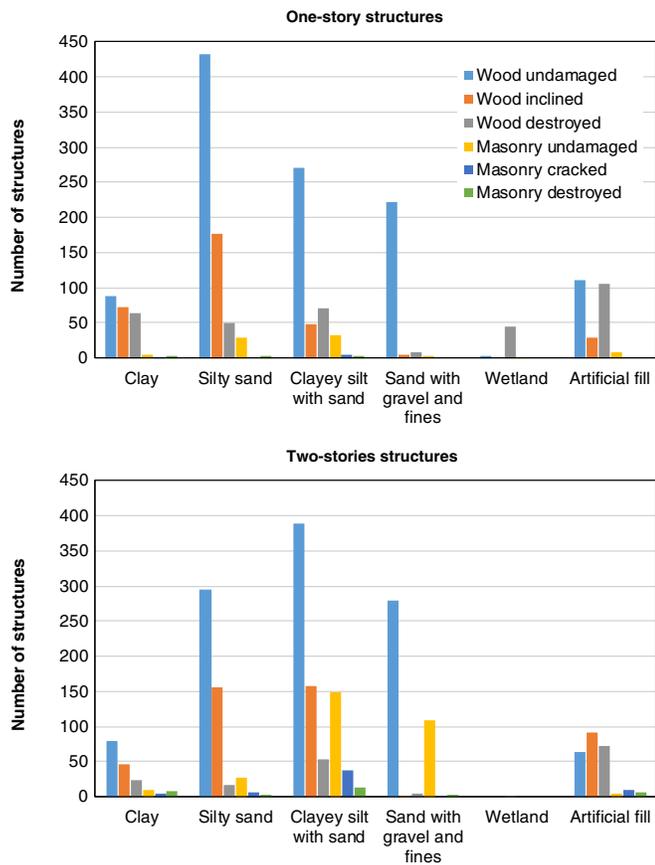
Figure 7. Number of one- and two-story structures undamaged, inclined, cracked, and destroyed during the earthquake, founded over soil types defined in the surface geology in Figure 2. The color version of this figure is available only in the electronic edition.

Figure 7 summarizes the number of undamaged, inclined, cracked, and destroyed structures founded over the different geologic units (data provided in Table 1). Most of the damage focused on structures over the artificial fill unit: 43% of the one-story wooden houses over the artificial fill were destroyed, along with 32% of the two-story houses made of wood and masonry. The geologic unit that follows in terms of damage was the clay unit. In contrast, the unit over which the structures experienced less pronounced damage was the well-graded sand with gravel and fines. We summarize the spatial correlation between the local site conditions and the damage pattern in Figure 8, considering destroyed, inclined, cracked, and undamaged structures.

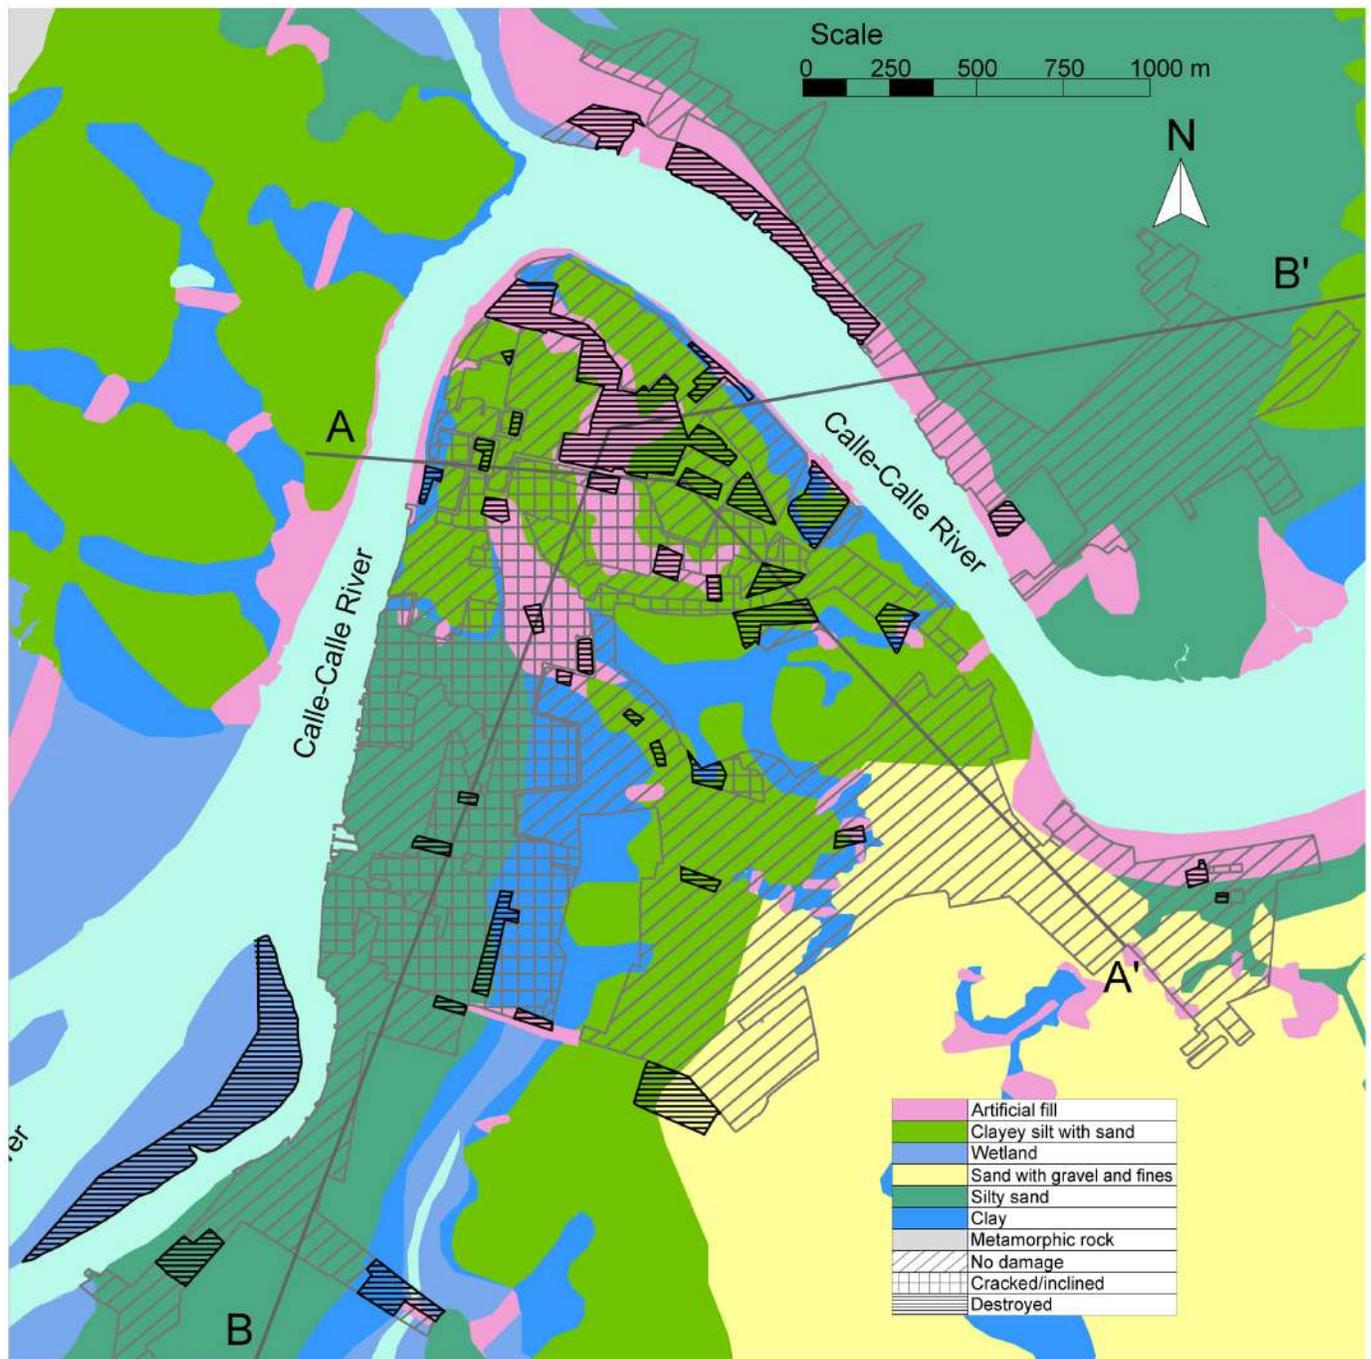
Figure 8. Correlation between surface geology and structural damage. The color version of this figure is available only in the electronic edition.
